The Road Inventory of Muleshoe National Wildlife Refuge Muleshoe, TX

Prepared By:
Federal Highway Administration
Central Federal Lands Highway Division
December 2009

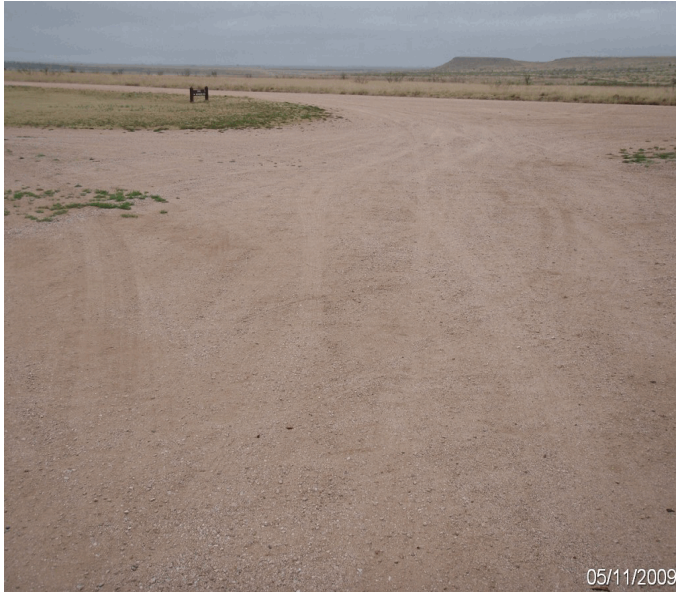
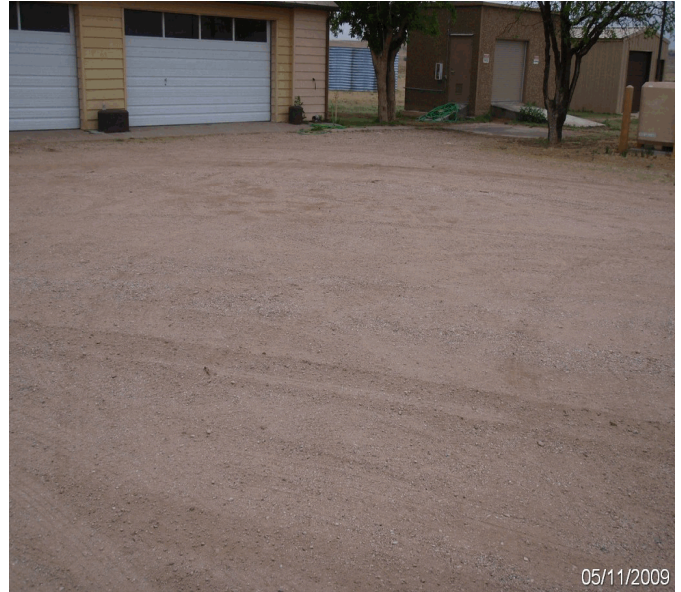
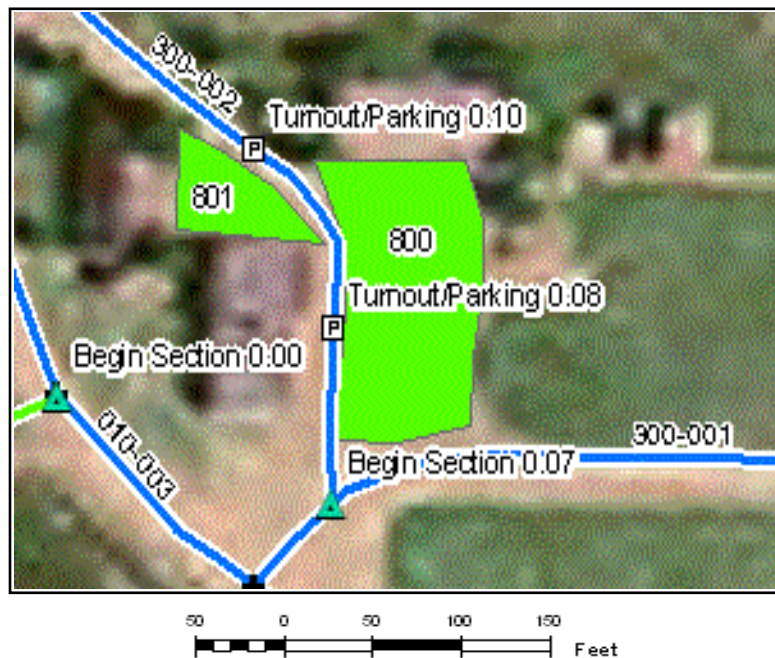
Asset Number	Date Visited	Surface Type	Area (Sq Ft)	Condition	Cost to Improve
	05/11/2009	Gravel	6,444	Good	1,000

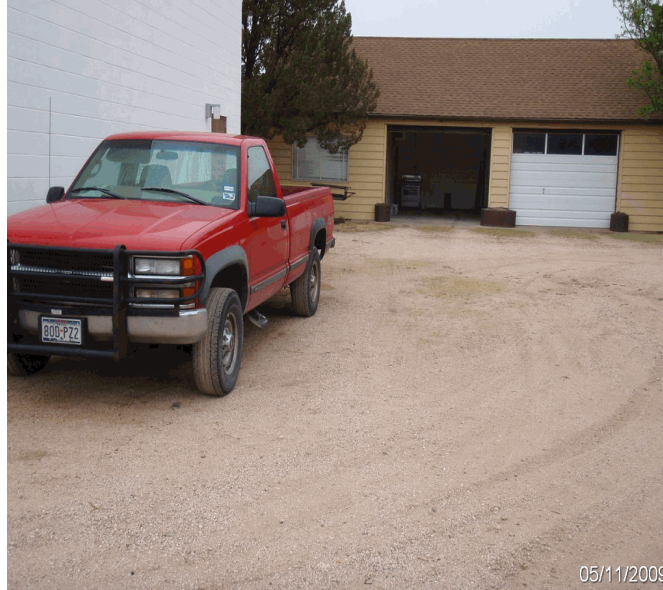
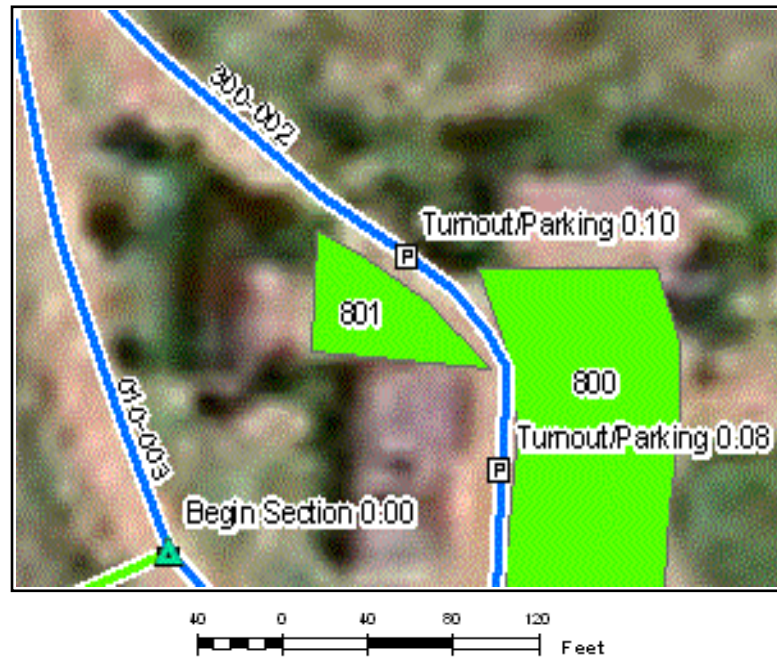
801: Shop Parking Area

Asset Number	Date Visited	Surface Type	Area (Sq Ft)	Condition	Cost to Improve
	05/11/2009	Gravel	1,491	Good	200

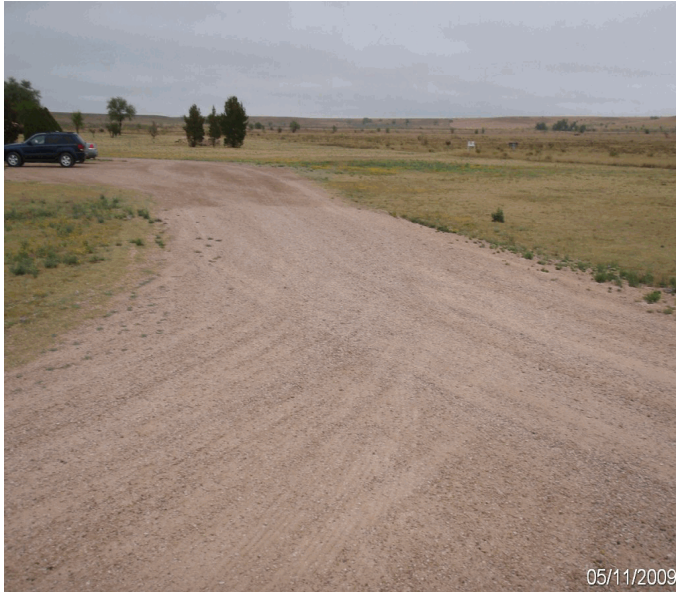
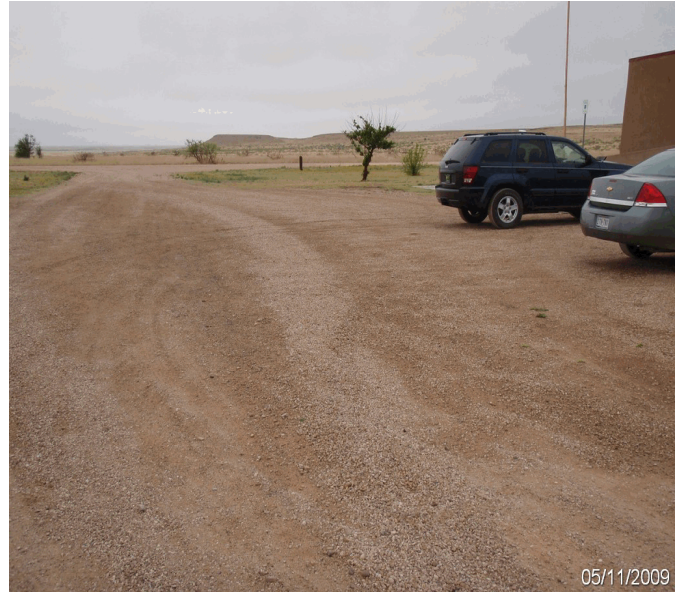
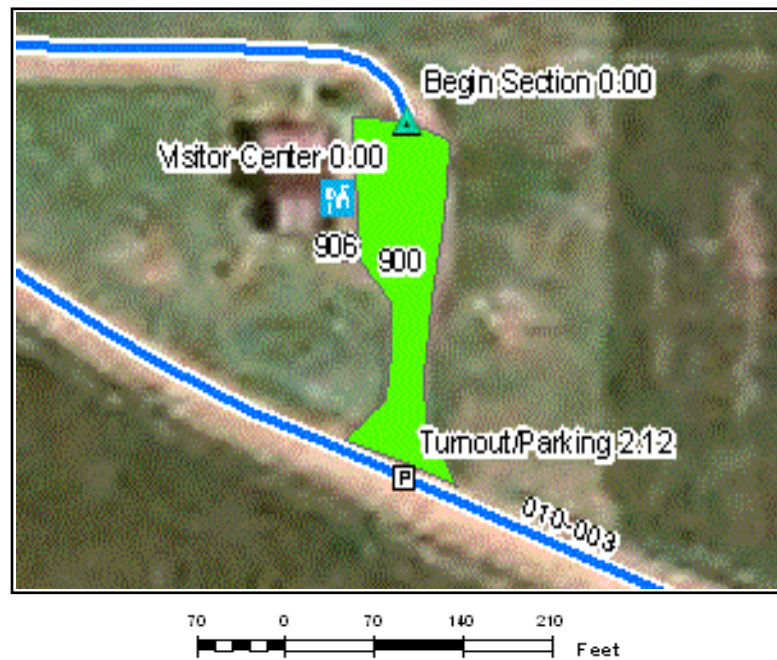
900: Visitor Center Parking Area

Asset Number	Date Visited	Surface Type	Area (Sq Ft)	Condition	Cost to Improve
10008049	05/11/2009	Gravel	7,573	Good	1,100

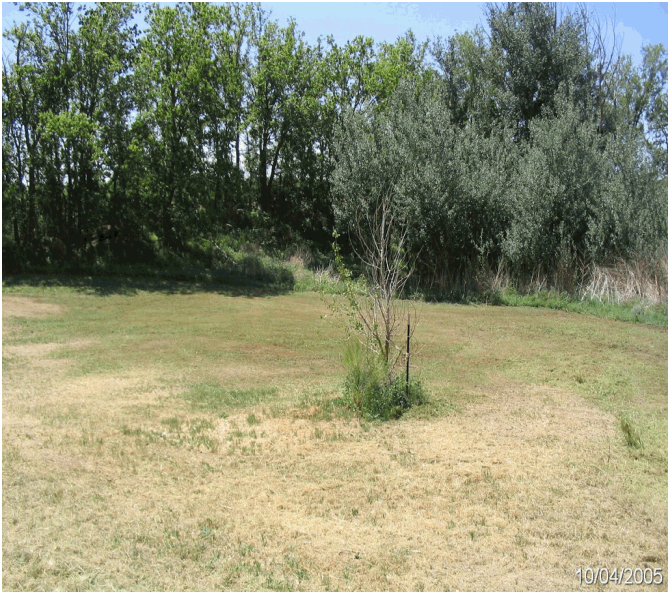
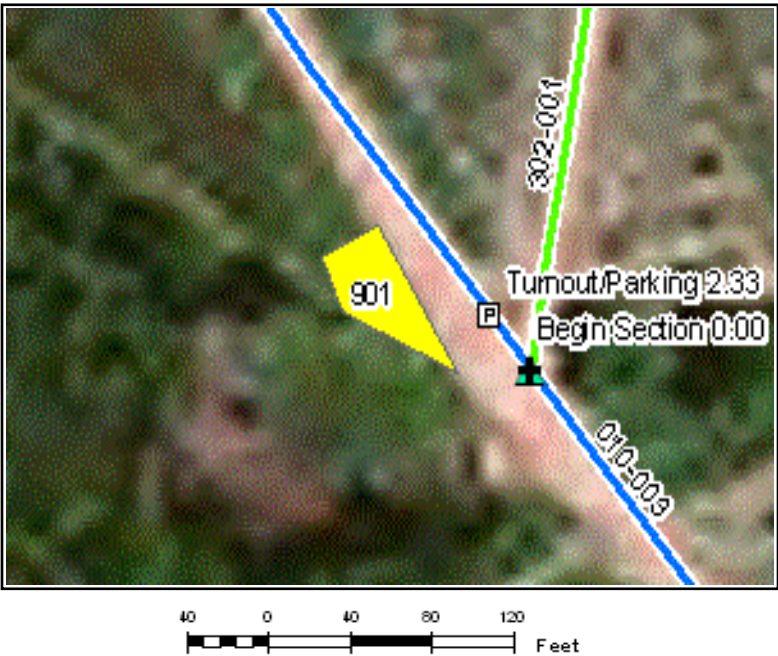
901: Trailhead Parking Area

Asset Number	Date Visited	Surface Type	Area (Sq Ft)	Condition	Cost to Improve
10008049	05/10/2005	Native	1,019	Fair	300

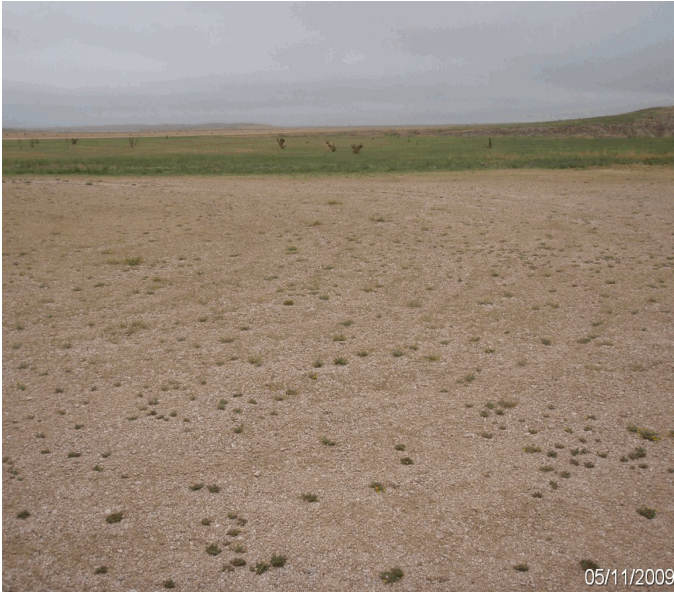
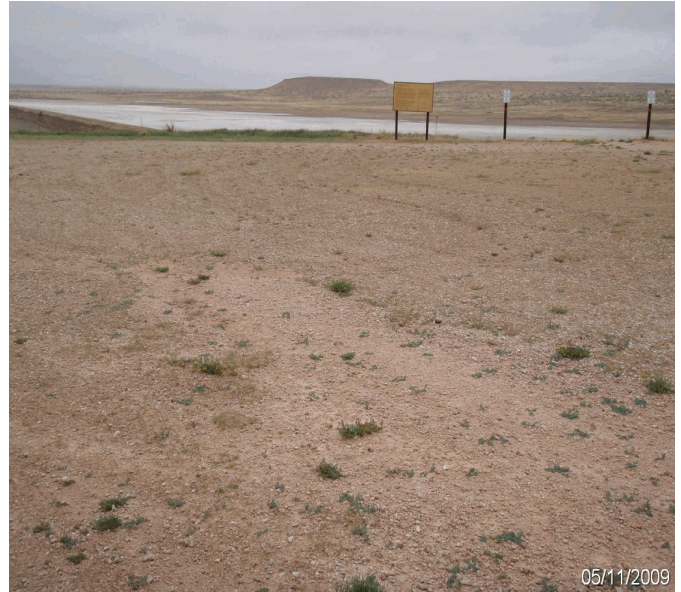
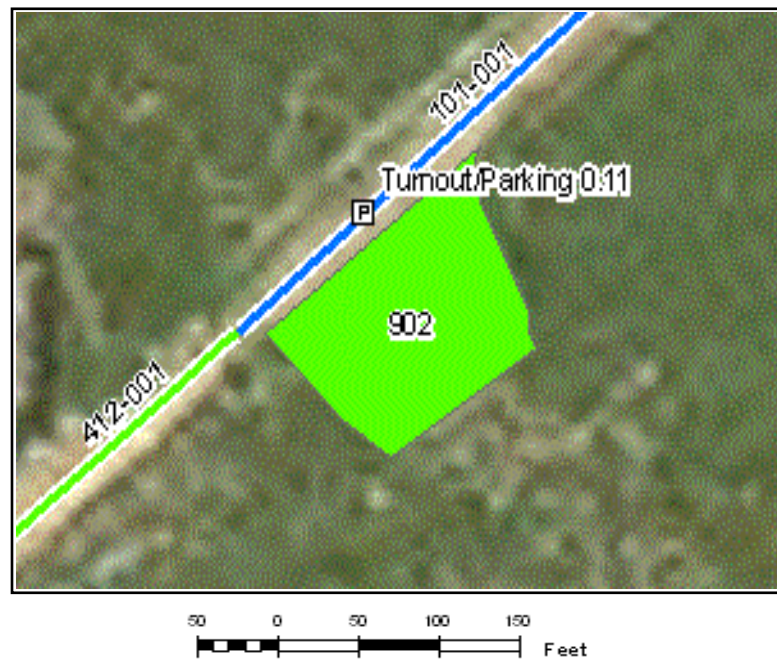
902: White Lake Parking Area

Asset Number	Date Visited	Surface Type	Area (Sq Ft)	Condition	Cost to Improve
10008049	05/11/2009	Native	8,622	Good	1,300

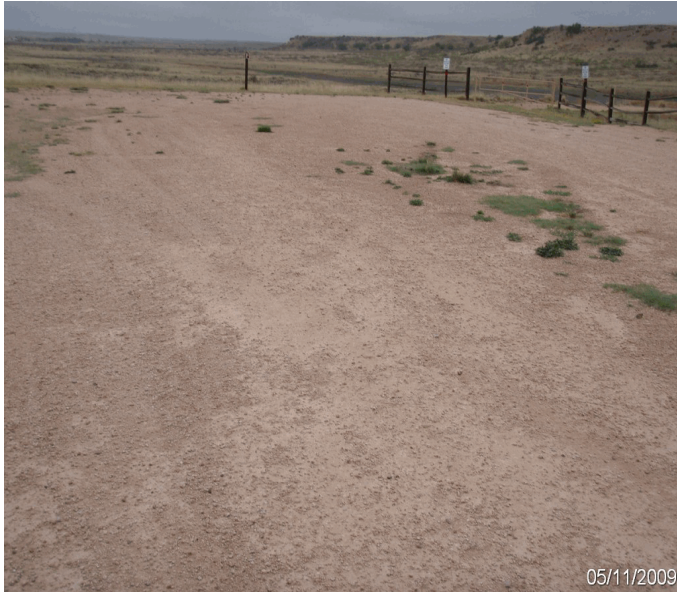
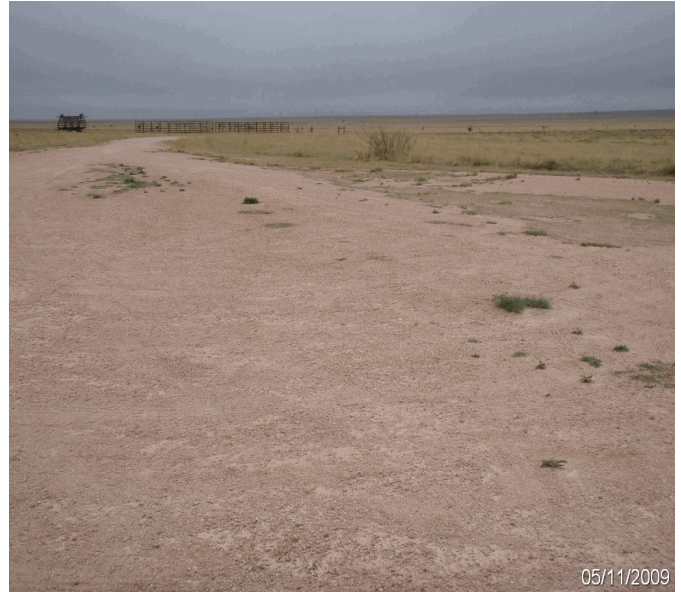
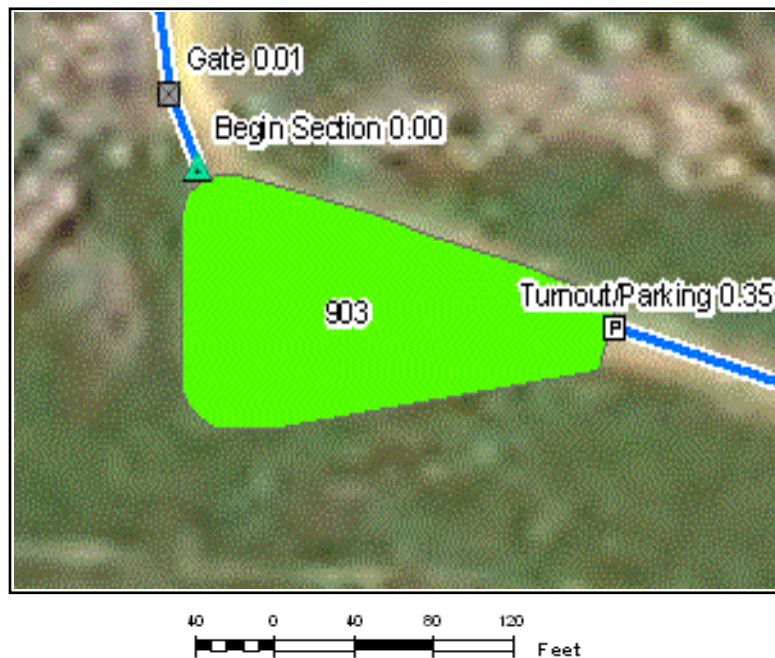
903: Goose Lake Parking Area

Asset Number	Date Visited	Surface Type	Area (Sq Ft)	Condition	Cost to Improve
10008049	05/11/2009	Gravel	10,167	Good	1,500

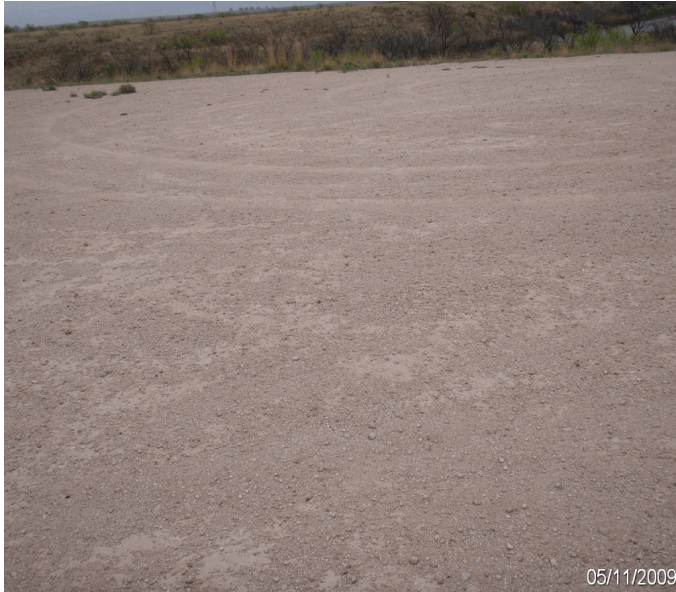
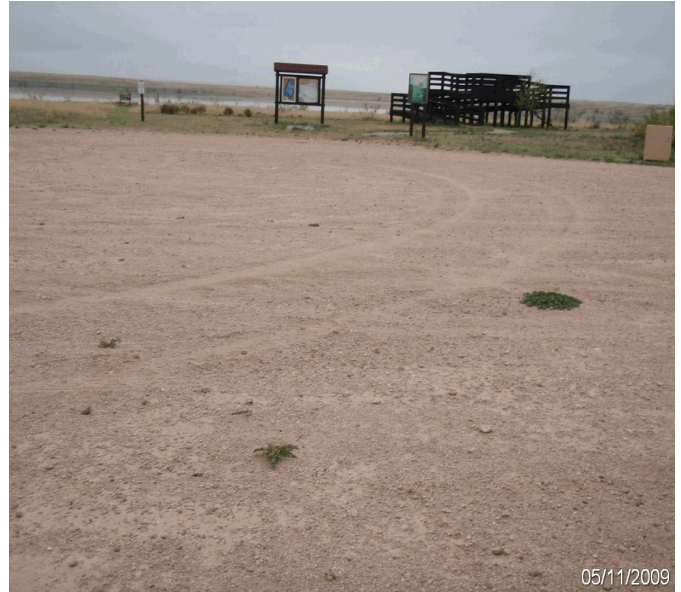
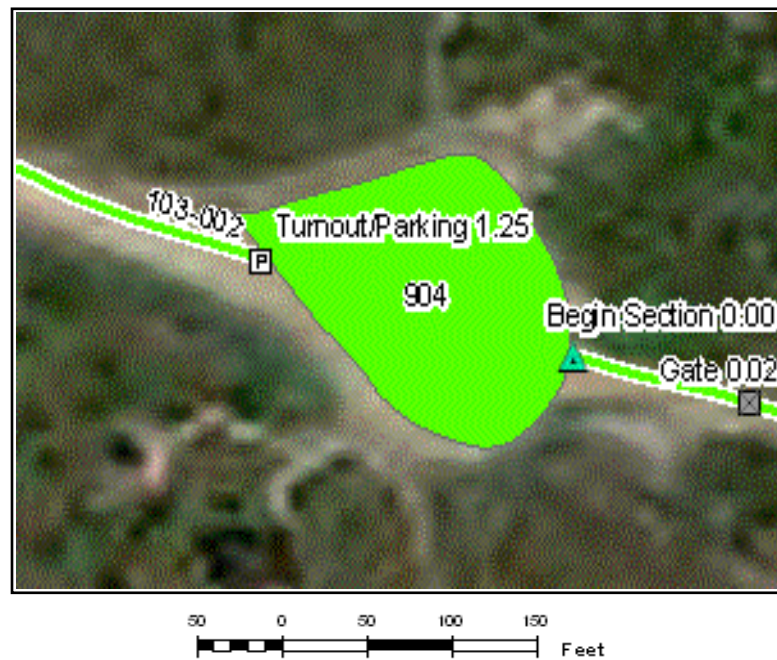
904: Paul's Lake Parking Area

Asset Number	Date Visited	Surface Type	Area (Sq Ft)	Condition	Cost to Improve
10008049	05/11/2009	Gravel	11,209	Good	1,700

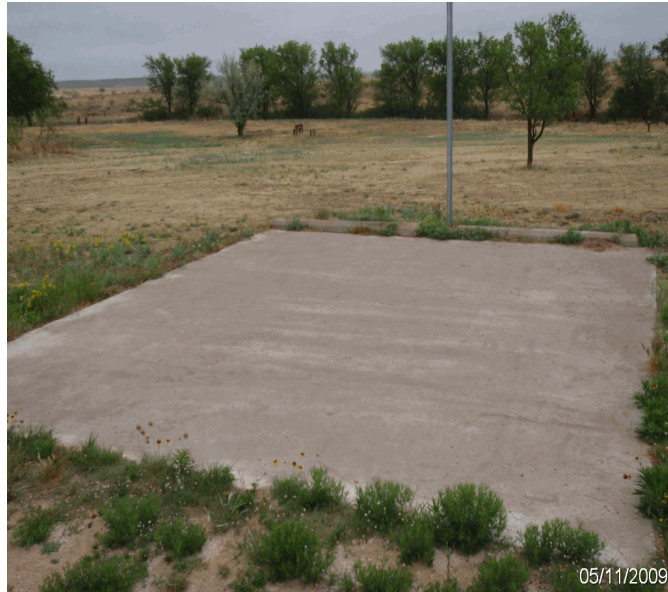
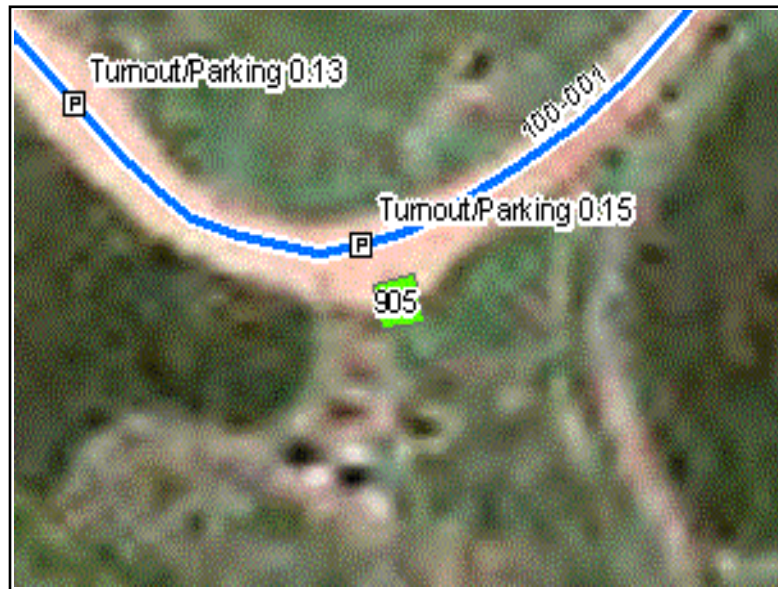
905: Camping Loop Handicapped Parking

Asset Number	Date Visited	Surface Type	Area (Sq Ft)	Condition	Cost to Improve
	05/11/2009	Concrete	308	Good	0

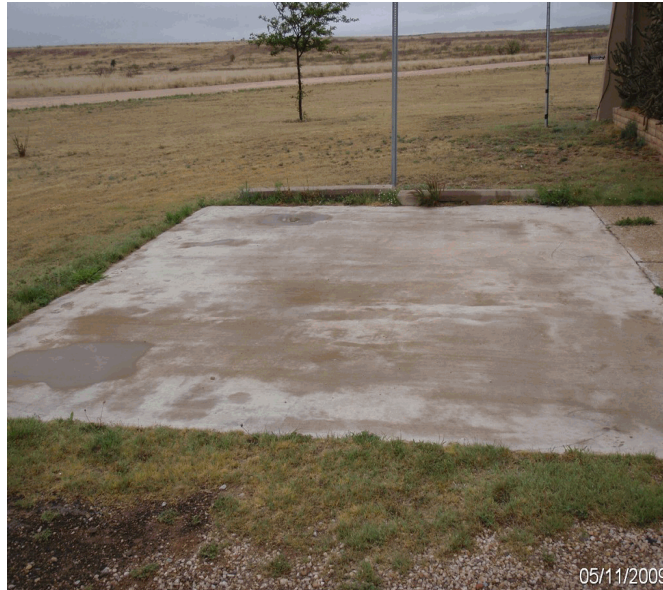
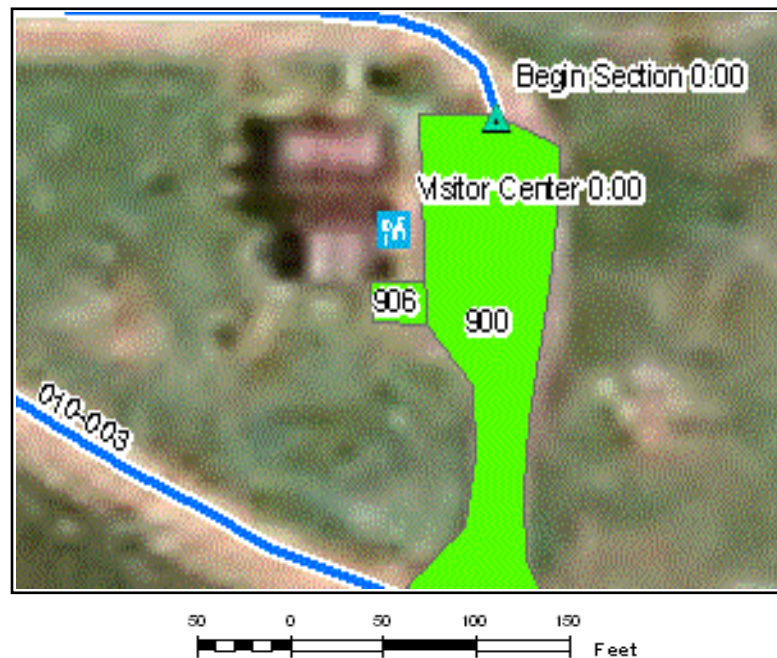
906: Visitor Center Handicapped Parking

Asset Number	Date Visited	Surface Type	Area (Sq Ft)	Condition	Cost to Improve
	05/11/2009	Concrete	345	Good	0
